**Vehicles Affected:** 2003—2012 Ford F150, Expedition, & Lincoln Navigator 4WD models.

**Customer Complaint:** Four Wheel drive will not engage, may be intermittent at 1st but becomes more frequent, may also notice grinding noise from front tire area when vehicle is in 4WD.

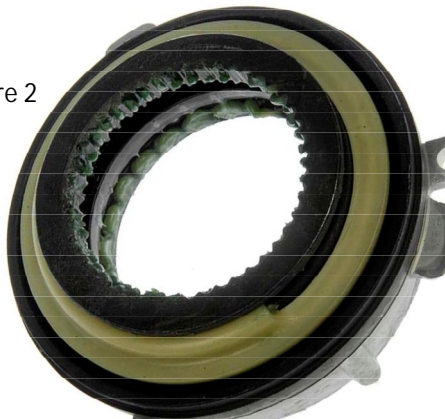
Picture 2

**Technician will find:** Front vacuum actuator not fully engaging or not engaging at all. Upon disassembly will notice teeth stripped/worn on actuator and on wheel bearing hub assembly because actuator was not fully seating and teeth were slipping.

**How it works:** This is a vacuum operated set up. A vacuum command switch (MTC CX2117 2004-2009 picture 1) controls the vacuum flow. Vacuum to the front actuator (Dorman 600-105 picture 2 & 3) pulls the gear so it locks with the gear on the hub bearing (Timken SP550207 for 2004-2008 picture 4 & 5). When the gears are locked to each other the vehicle is in 4WD.

**Tech Tip:** It is important to make sure all components are working correctly and that all vacuum lines hold vacuum. If just the actuator is replaced and other parts of the system are not working properly this will result in a comeback. If the gears on the hub bearing are worn they will cause premature failure of the actuator. If the vacuum switch is not holding properly it will cause gears on actuator to slip on hub bearing gears and over time strip them out.
