## Air Conditioning Is Not Cold Enough (Replace Condenser) #02-01-38-004A - (Apr 27, 2005)

2002 Buick Rendezvous

2001-2002 Chevrolet Venture

2001-2002 Pontiac Aztek, Montana

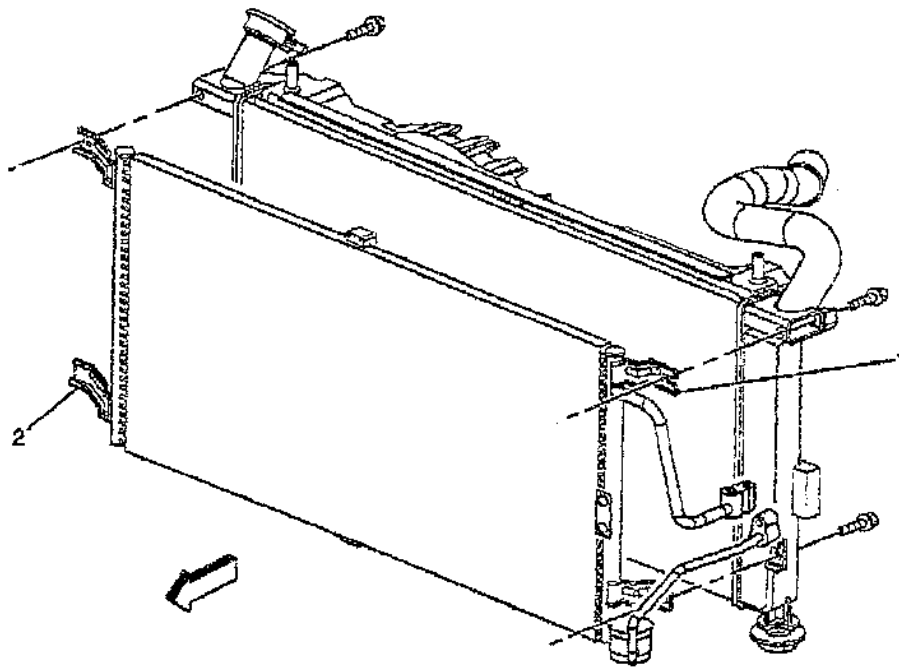
Technicians may find that the condenser is cracked and leaking at the lower right attachment bracket.

3. Refer to (1) and (2) in the illustration above to find the locations where the condenser to radiator mounting will be changed.
4. At (2), (lower right attachment bracket), the new condenser will not have a hole in the bracket. Discard the bolt and J-nut that was used at this location with the original condenser.
5. At (1), (upper left attachment bracket), install a new J-nut, P/N 10335492, on the slotted condenser attachment bracket. Reuse the bolt that was in this location with the original condenser.
6. Perform all the rest of the steps listed in the replacement procedure.
