Upper Ball Joint Replacement

Removal and Inspection

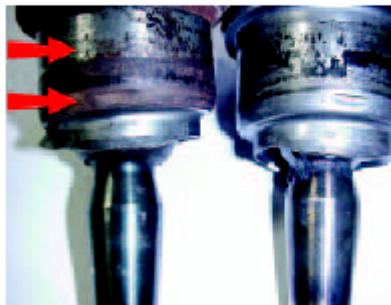
Inspect the old ball joint housing prior to removal from the control arm to determine if excessive wear has caused the control arm hole to become elongated.

Inspect ball joint housing for excessive wear

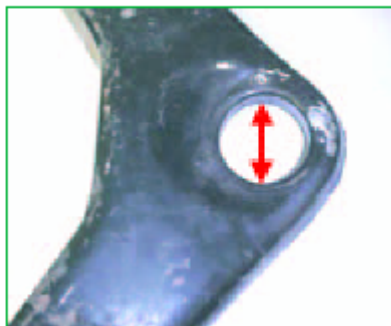
The stamped steel upper control arm may be stretched out of round when removing the worn upper ball joint. The control arm hole may measure as much as 0.018 inches larger than the original size.

Pressing out an old ball joint (with a damaged housing) typically enlarges the control arm hole. The expanded hole does not allow for an adequate mechanical bond between the new ball

Check hole diameter for elongation

The hole diameter specification is 45.825mm \pm 0.025mm or 1.804 inches \pm 0.001 inches.

Control arm holes that show any signs of wear, fatigue, an oblong shape or other damage must be replaced.

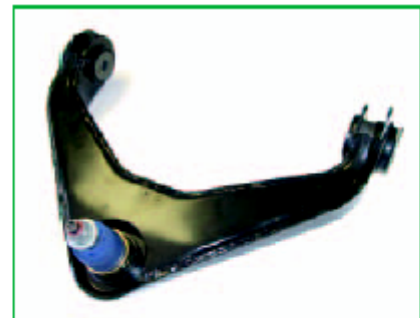
Control arm assembly with ball joint

ACDelco now offers a complete control arm assembly (ACDelco part number 45D1083) with the ball joint installed.

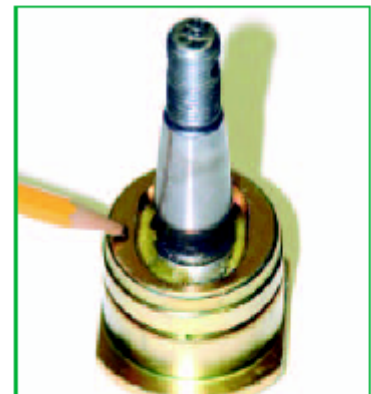
Incorrect installation may damage the ball joint and cause premature failure.

INSTALL INBOARD is stamped on the bottom of upper ball joint

INSTALL INBOARD is stamped on the bottom of the upper ball joint at a right angle to the large flat on the ball joint housing. Install the ball joint with the INSTALL INBOARD facing the engine compartment.
